EN 1634-1:2014/A1:2018

Fire Resistance Test for Doorset

A report to:
Shenzhen YLI Electric Lock Co., Ltd.

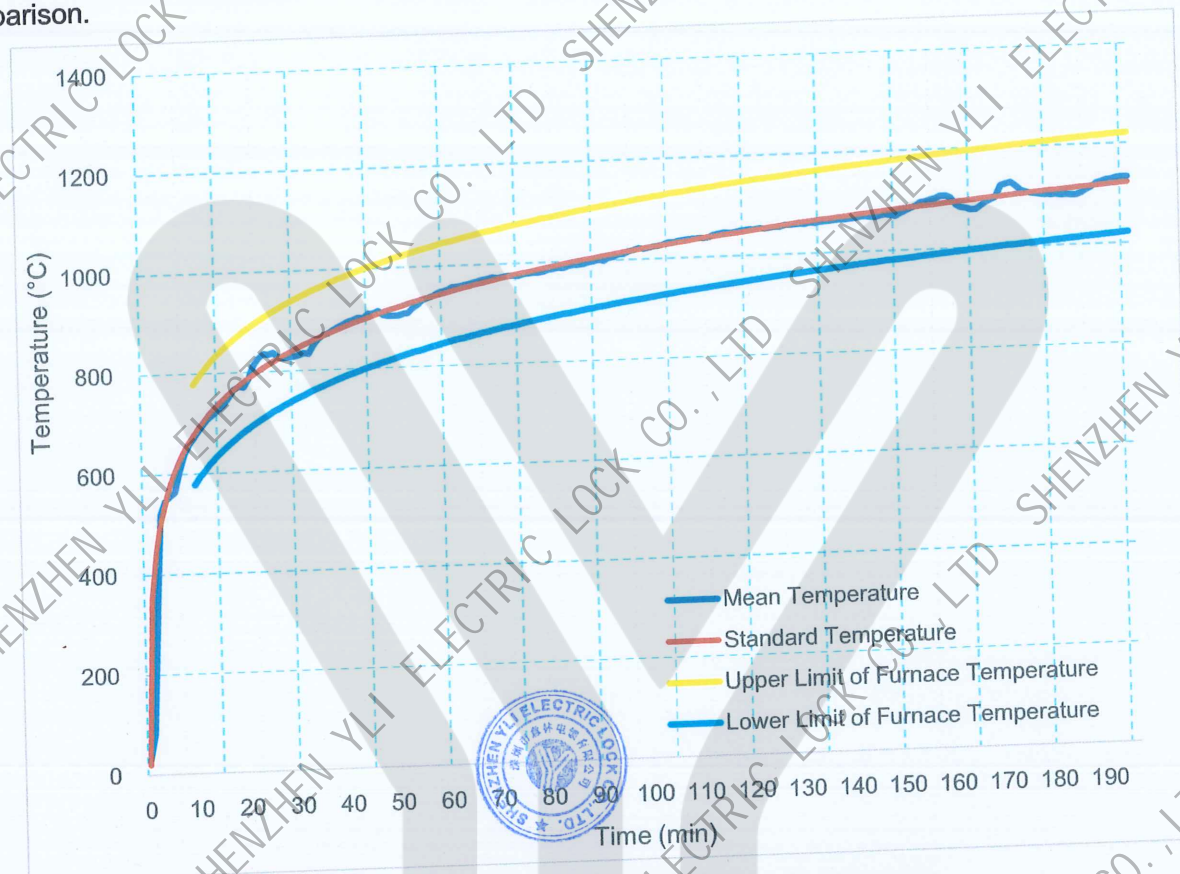
Graph 1 Furnace Mean Temperature / Time Curve

The mean furnace temperature recorded was plotted against time in Graph 1 with the specified curve for comparison.

Time Min	Mean Temperature	Standard Temperature	Diff%	Ambient Temperature
0	28.8	20.0	/	28.0
15	728.0	738.6	5.3	28.5
30	828.6	841.8	0.5	29.0
45	909.4	902.3	0.1	29.4
60	949.1	945.3	0.0	29.8
75	975.1	978.7	-0.1	30.4
90	998.5	1006.0	-0.2	30.6
105	1031.9	1029.1	-0.2	30.5
120	1051.2	1049.0	-1.0	30.8
135	1062.7	1066.7	-1.1	31.1
150	1069.6	1082.4	-1.0	31.4
165	1077.7	1096.7	-1.0	31.0
180	1102.3	1109.7	-0.9	31.1
196	1133.2	1122.5	-0.8	31.5

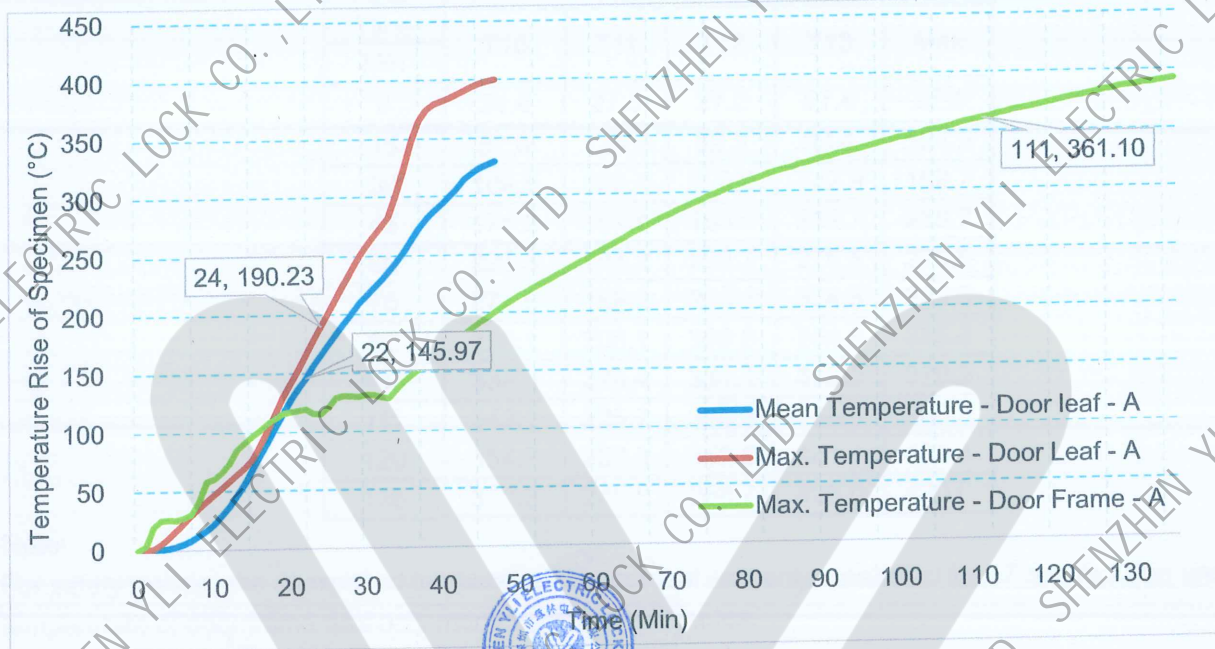
Graph 2a The mean and maximum temperatures raises/time curve

The mean and maximum temperatures raise of the unexposed face of Doorset A were shown in Graph 2a.

The door leaf of Doorset A mean temperature rise for insulation (140°C rise) was exceeded at 22 min. The door leaf of Doorset A maximum temperature rise for insulation (180°C rise) was exceeded at 24 min. The door frame of Doorset A maximum temperature rise for insulation (360°C rise) was exceeded at 111 min. The individual temperatures recorded on the unexposed face of the Doorset A were shown in Table 5a.

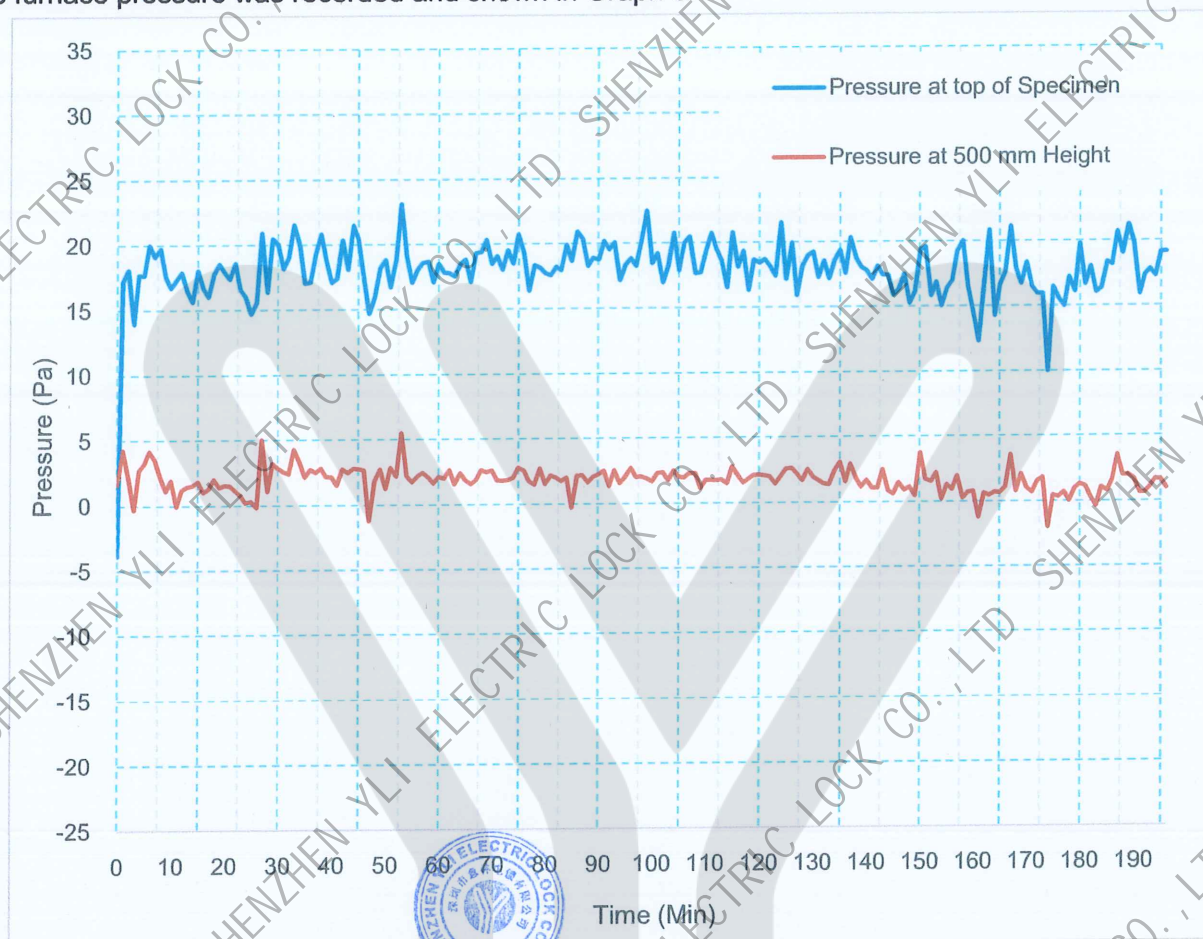
Graph 3 Furnace Pressure / Time Curve

The furnace pressure was recorded and shown in Graph 3.

Two pressure sensors were provided to monitor and control the furnace pressure after the first five minutes of testing the furnace atmospheric pressure so that it complied with the requirements of Clause 5.2 of EN 1363-1:2020. The pressure condition was assumed a linear pressure gradient of 8.5 Pa per 1 m and a neutral pressure axis at a height of approximately 0.5 m above the notional floor. The pressure at the top of test specimen was controlled within 20 Pa.
